THE RESULTS ARE IN: MOTOR REPAIR'S IMPACT ON EFFICIENCY

Austin Bonnett
 Education and Technology Consultant
 Electrical Apparatus Service Association, Inc.
 St. Louis, MO

Brian Gibbon
 Dowding and Mills PLC
 Birmingham, England

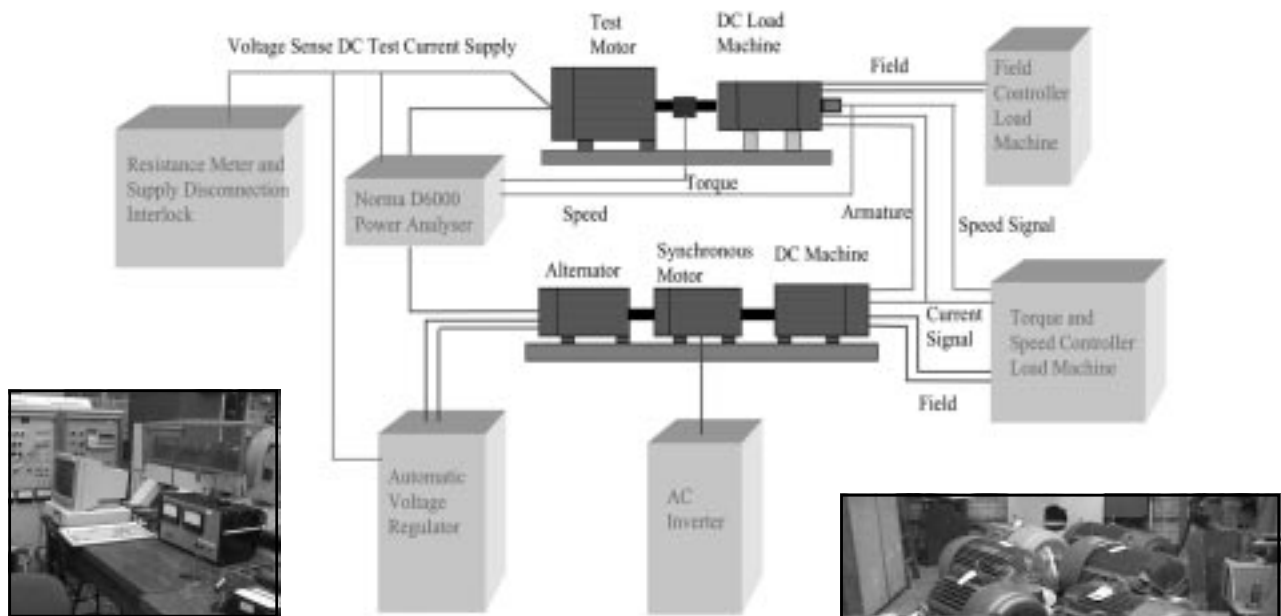
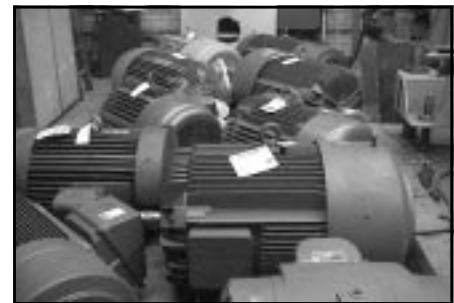
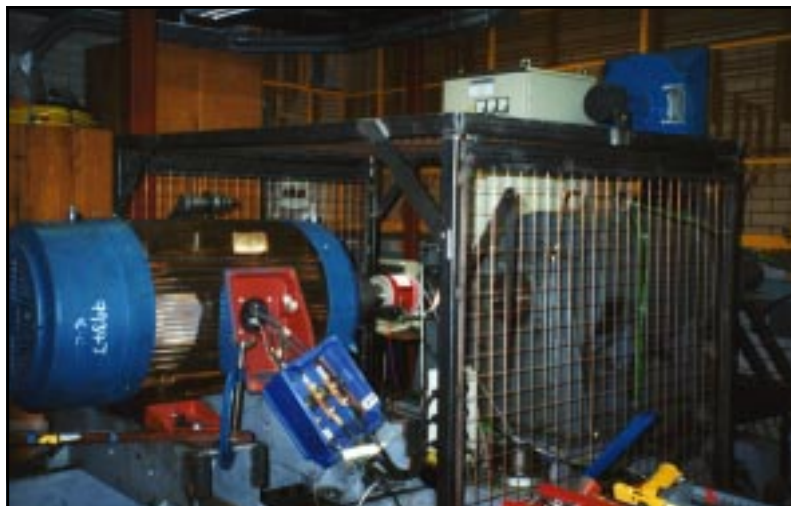
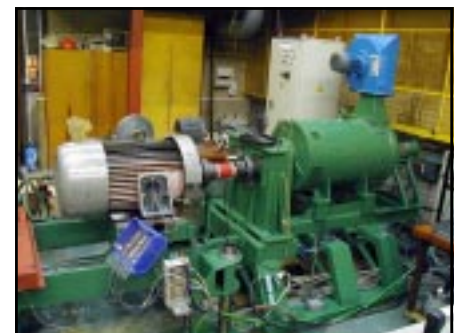
**FIGURE 1
UNIVERSITY OF NOTTINGHAM TEST FACILITY**

- Ten motor manufacturers provided motors, technical data and assistance for the study: ABB, Baldor, Brook Crompton, GEC, Leeson, Reliance, Siemens, Toshiba, U.S. Electrical Motors and VEM.
- The Dowding and Mills facility in Birmingham, UK, carried out all motor rewinds and repairs.
- The University of Nottingham performed efficiency testing on their dynamometers in Nottingham, UK (see Figure 1).

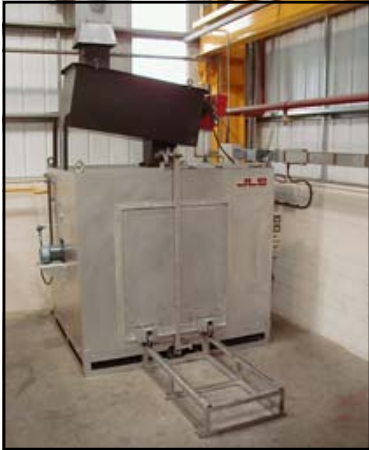
It is important that this process be tightly controlled. Burning out at a temperature below 680° F (360° C) may not leave the core clean. Additional cleaning of the core may cause mechanical damage (e.g., splayed teeth) that will increase the stray losses. Burning out at more than 680° F (360° C) for organic coreplate or 750° F (400° C) for inorganic coreplate may increase the risk of damaging the interlaminar insulation and increase the core losses if the interlaminar insulation is not inorganic coreplate material.

Dowding and Mills burnout oven.

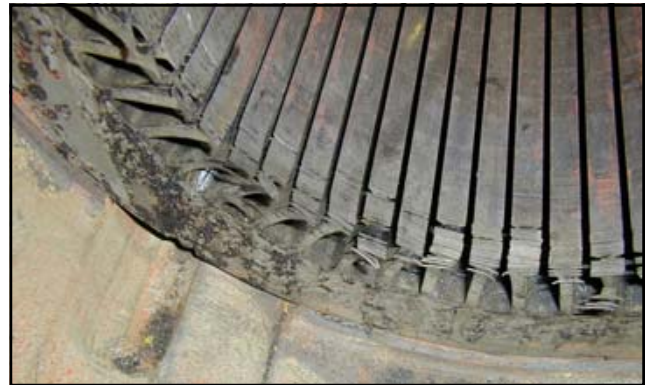
FIGURE 3
END LAMINATIONS

An example of end laminations damaged during coil removal.

Example of end laminations in good condition.

Cutting the endwinding with an air chisel resting against the core end laminations or causing the end laminations to flare when pulling the coils out of the slot will increase the stray losses (see Figure 3).

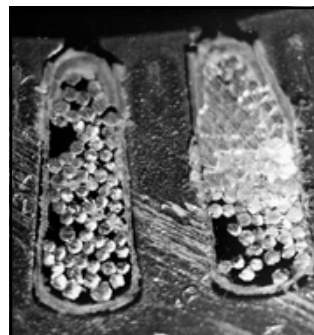
FIGURE 4
EXAMPLES OF SLOT FILL

Poor slot fill

Good slot fill

One of the easiest ways to improve motor efficiency is to increase the relative slot fill (conductor cross-sectional area) of stators originally wound with low or moderate slot fills. Table 5 shows examples where efficiency could be improved.

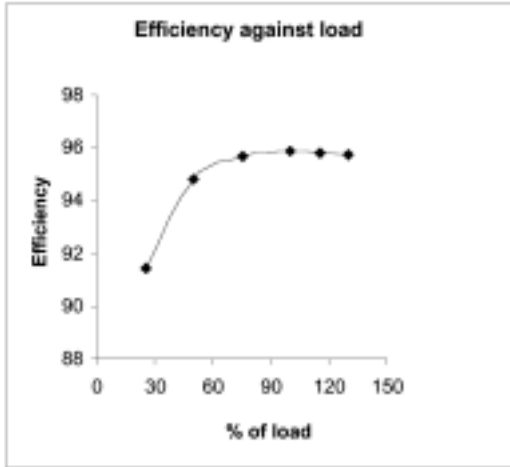
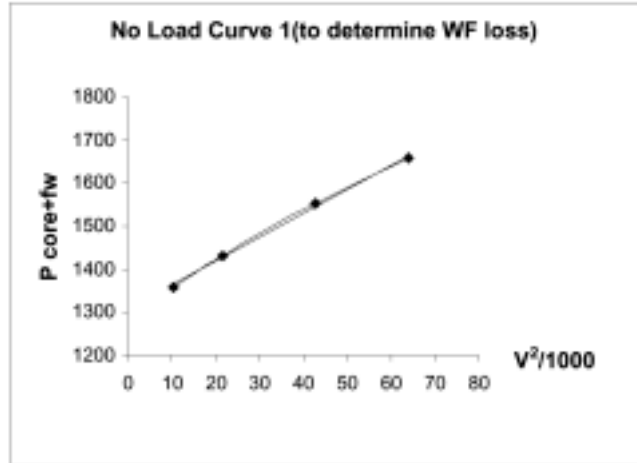
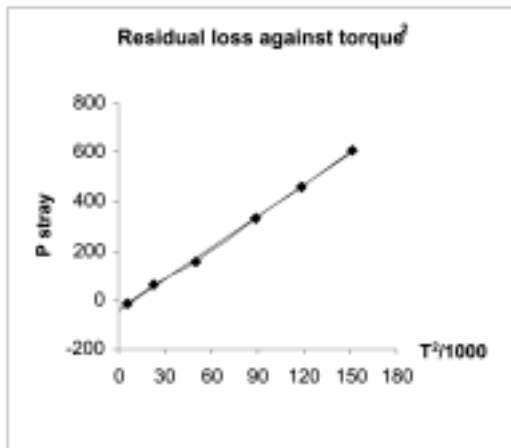
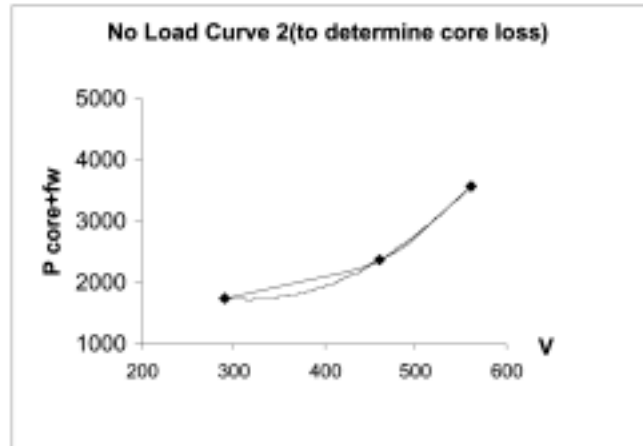
ITEM 1 (CONTINUED): SAMPLE LOSS COMPARISON AND TEST DATA

This is typical data obtained for each of the before and after rewind testing done at the University of Nottingham. The curves on the following page were generated from this information.

These curves were generated from the data collected on the previous page.

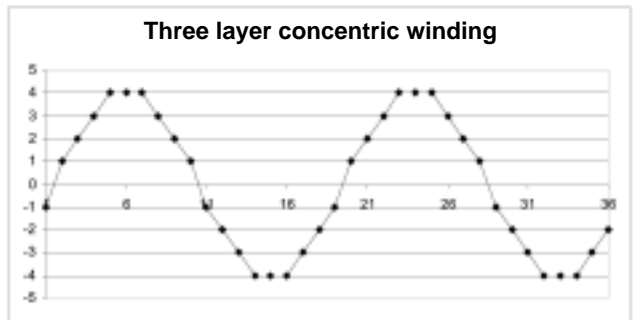
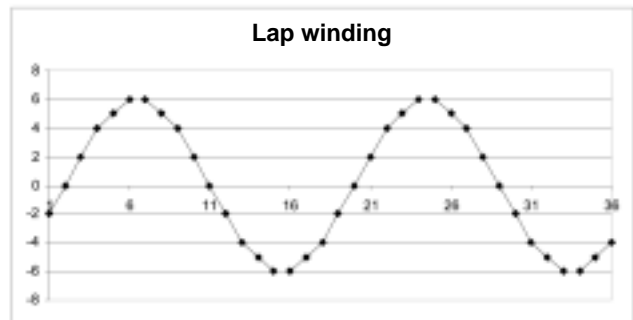
These charts show the MMF patterns for a 36-slot, 4-pole winding. The 3 plots represent a two-layer concentric winding, a three-layer concentric winding, and a lap winding, span 1-8.

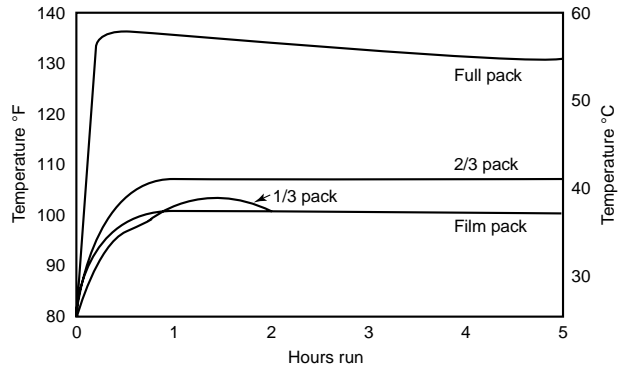
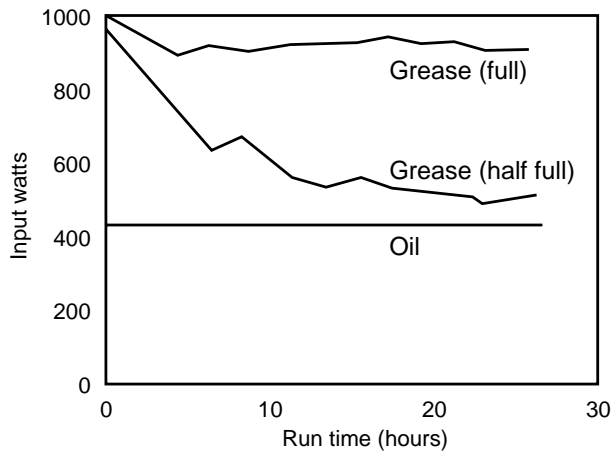
ITEM 4: IMPACT OF TOO MUCH BEARING GREASE

A number of tests conducted over the years illustrate the impact of over-greasing of bearings on the friction losses (see the accompanying graphs). On two of the units tested in Stage 1, grease was added to the bearings after rewinding. On all other motors tested no change was made to the lubrication. As expected, the bearing friction loss increased on the regreased motors. The impact on the efficiency of the respective motors was -0.3% and -0.5%.

Over-lubrication of bearings will increase friction losses and shorten bearing life. Mixing incompatible greases will increase friction losses and impair lubrication. Use sealed-for-life bearings (do not replace open or shielded bearings with sealed bearings unless they are the non-contact type) or open bearings with manufacturer's recommended grease fill. Ensure that bearings have the same internal clearance as original bearings (for example, C3). Decreasing the clearances could increase the friction losses. (See Appendix, Item 4.)
